## Snap-Tite® Lines Oval Culvert under Remote Alaskan Airport Taxiway, Flights Resume as Scheduled

*Yakutat, Alaska*

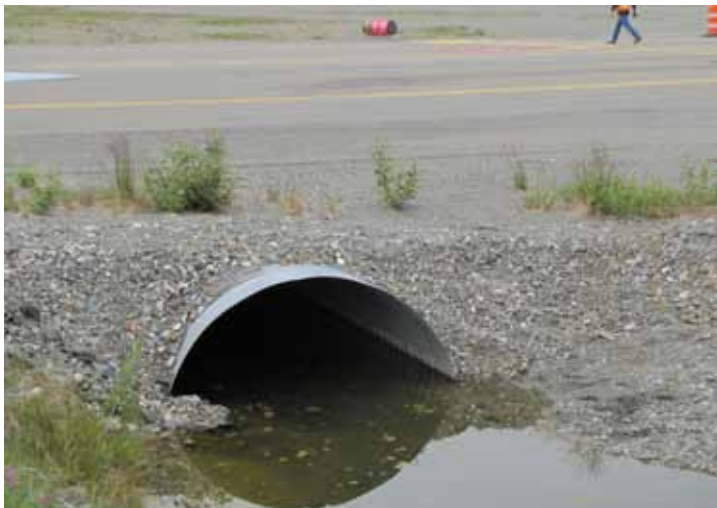
At the Yakutat Airport, a major airline was not able to use its main taxiway to reach the runway for take-off due to a failing oval culvert underneath. The culvert showed signs of collapse under the weight of the Boeing 737-800 series aircraft that used the taxiway. The steel pipe was only five years old and though it did not show signs of corrosion, it was failing. The arched corrugated metal pipe (CMP) culvert was 6'9" by 4'11". Besides aircraft trafficking over this taxiway, the 737 rear landing gear also sat right on top of the underlying pipe, contributing to the pressure placed on the culvert. The U.S. Federal Aviation Administration (FAA) required the airport to fix the problem immediately and have the taxiway up and running.

*The CMP buckeling under the pressure of the traffic on the taxiway.*

Another consideration was to use a smaller, standard round Snap-Tite® pipe liner (24-inch diameter pipe) to line the culvert while using grout to fill the larger annular space between the old culvert and the new Snap-Tite® pipe. The proposed grout mix had to meet the specified design loads anticipated at the site – the static force of Boeing 737-800 series aircraft at maximum takeoff. The grout mix design had to achieve sufficient strength. Snap-Tite recommended a grout mix that would meet the necessary pressure rating to withstand the taxiway loads. The high pressure grout and 24-inch Snap-Tite® pipe liner option was chosen as the best solution.

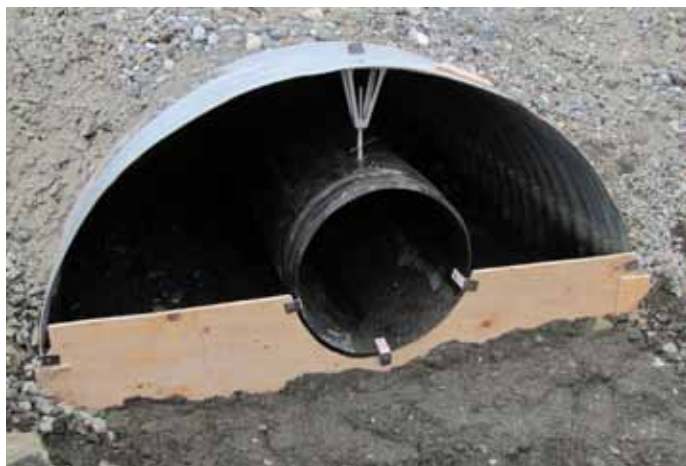
*The first bulkhead is created after the pipe liner is inserted and before the grout is pumped in.*

Prior to inserting the Snap-Tite® pipe into the culvert, all the sections of the Snap-Tite® pipe were snapped together outside of the channel. Then, the joined pipe was rolled down into the channel and inserted inside the culvert. Once the Snap-Tite® pipe liner was in, the channel was de-watered. The liner was secured in place using metal stabilizing jacks from the top of the culvert to the liner. Then the first bulkhead was put in place and grouting tubes inserted for the initial phase of the grouting process. The first phase of grout was pumped in through the tubes above the Snap-Tite® pipe liner starting at the center and alternating side-to-side from both ends.

Then the second bulkhead was put in place for the second grouting phase, just over the pipe liner. The second phase of grout was pumped in similarly to the first method. Next a vent and observation ports were cut on the top of both ends of the CMP.

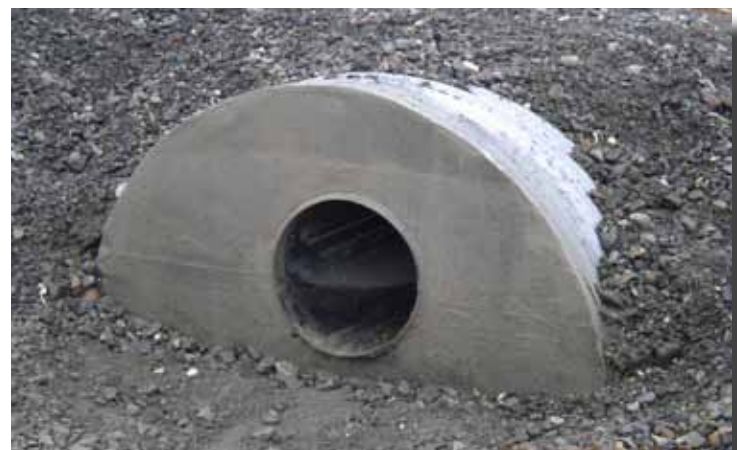
*The installation is complete. The culvert is lined with Snap-Tite® pipe and the annular space is filled in with high-pressure grout.*

The old culvert was successfully lined with the 24-inch Snap-Tite® pipe. It took a total of 85 cubic yards of grout to fill the annular space. In addition, throughout the project, grout cubes were taken and tested. The grout

yields and strengths were better than expected (approximately 3700 psi) and the taxiway opened back up to normal operations on schedule.
