Snap-Tite Provides Solution for Sloped Culvert

Coulee City, Washington

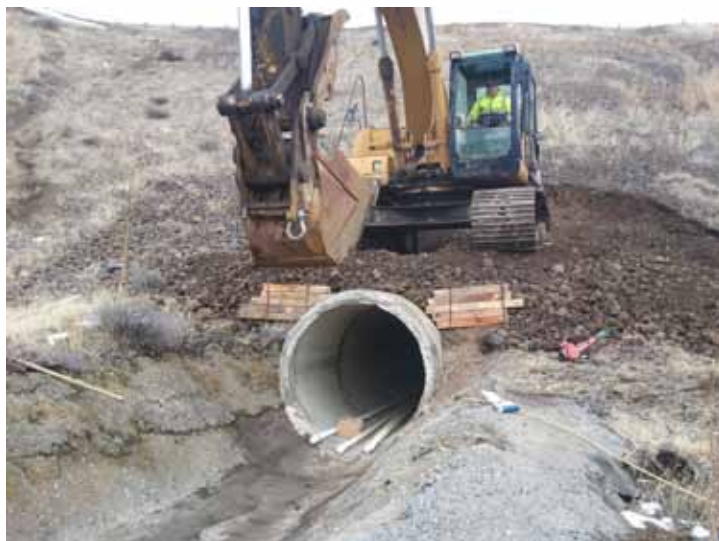
Just prior to the securing of the grout tubes.

in order to get through a portion of the pipe that was at an angle at approx. 165 feet from the inlet and 100 feet from the outlet. Each lining section weighed 2,880 pounds with a total weight of 33,000 pounds. Because of the very limited access, the liner was installed from the outlet end and pushed back uphill. As a result of the difference in elevation from the inlet end to the outlet end of 18 feet, it was necessary to install the grout into four individual and separate lifts.

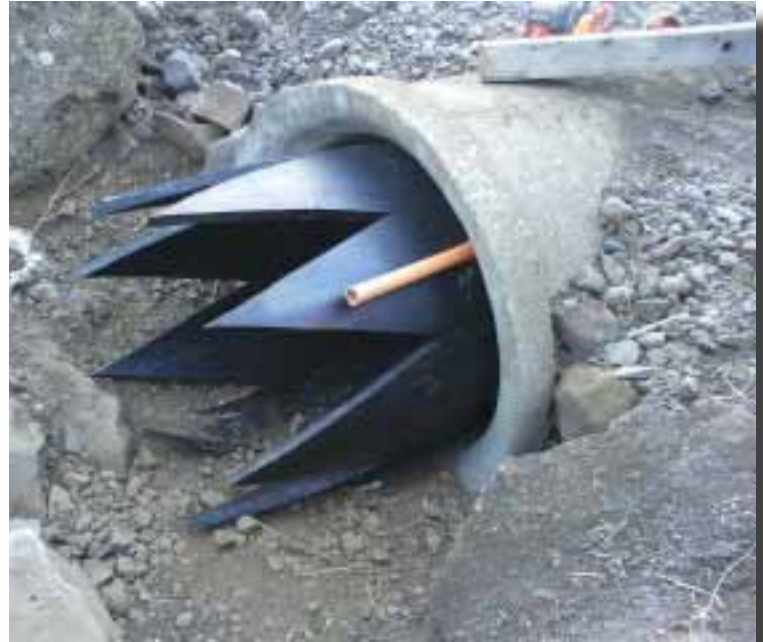
A nose cone coming through the pipe.

The 276 feet of 54-inch Snap-Tite lining system was installed using 24-foot lay lengths. It incorporated a bull nose end as the first piece

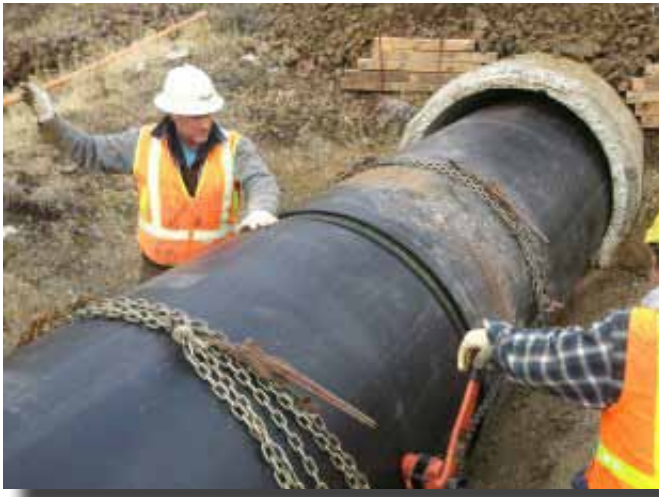
The Snap-Tite pipe during installation.

The high-density polyethylene (HDPE) Snap-Tite® pipe has a patented male/female machining at each end of the pipe sections. The machined sections are ‘snapped’ together, piece-by-piece, and pushed into the full length of an existing pipe. Any annular space and voids between the old culvert and new liner are filled in with grout. The pipe liner is available in lengths from two feet to 132 feet. Snap-Tite® also meets American Association of State Highway and Transportation Officials (AASHTO) Standard M326 for rehabilitating culverts.
